Linn Technical Support

Updating DS products to Bute software

Revision 1.0 June 11th 2008 Technical.Support@Linn.co.uk

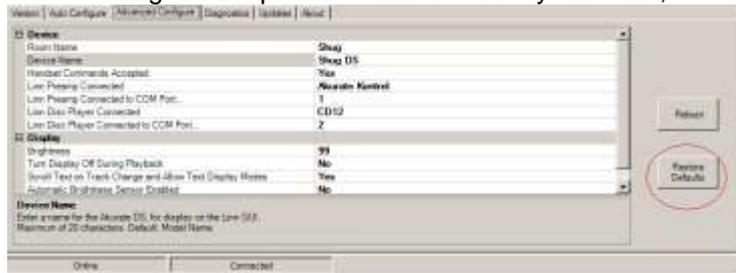
The DS products that have been recently updated to the Bute flash code may exhibit some control problems.

1. bring the DS product back to "Factory defaults",
